DEPARTMENT OF TRANSPORTATION

Contract #: 04-0120F4Cty: SF/ALA Rte: 80 PM: 13.2/13.9File #: 1.28**WELDING INSPECTION REPORT****Resident Engineer:** Siegenthaler, Peter**Address:** 333 Burma Road**City:** Oakland, CA 94607**Report No:** WIR-020226**Date Inspected:** 02-Feb-2011**Project Name:** SAS Superstructure**OSM Arrival Time:** 900**Prime Contractor:** American Bridge/Fluor Enterprises, a JV**OSM Departure Time:** 1730**Contractor:** American Bridge/Fluor Enterprises, a JV**Location:** Jobsite**CWI Name:** See below**CWI Present:** Yes No**Inspected CWI report:** Yes No N/A**Rod Oven in Use:** Yes No N/A**Electrode to specification:** Yes No N/A**Weld Procedures Followed:** Yes No N/A**Qualified Welders:** Yes No N/A**Verified Joint Fit-up:** Yes No N/A**Approved Drawings:** Yes No N/A**Approved WPS:** Yes No N/A**Delayed / Cancelled:** Yes No N/A**Bridge No:** 34-0006**Component:** SAS OBG**Summary of Items Observed:**

WELDING INSPECTION REPORT

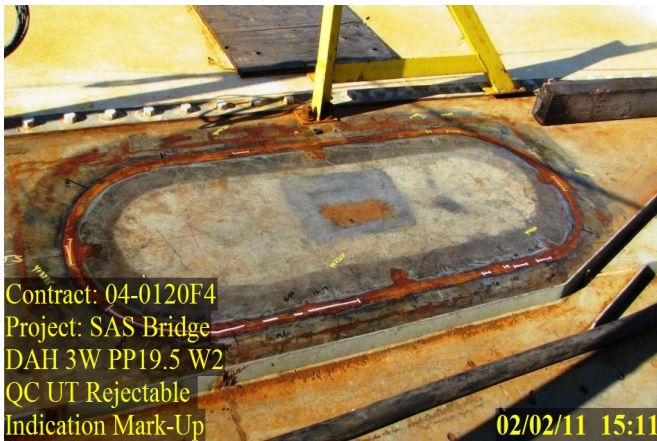
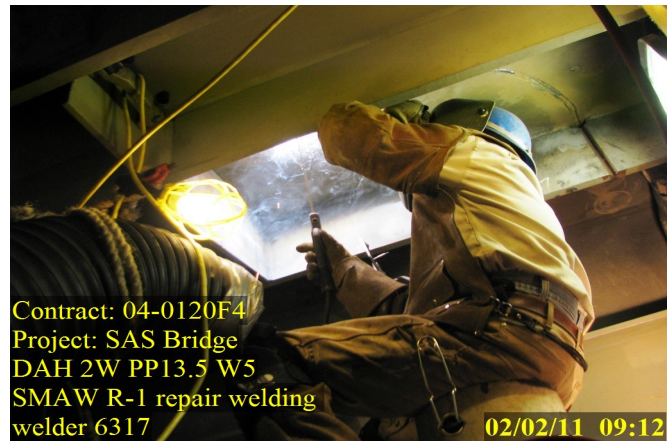
The QAI periodically observed AB/F approved welder Wen Han Yu (ID 6317) performing R-1 repair welding per the Shielded Metal Arc Welding (SMAW) process in the 4G (overhead) position on the interior of the DAH Insert Weld at OBG 2W PP13.5 W5. See photo below. QC Inspector Gary Ehram was present to monitor the progress and verify that the welding parameters were within the limits established by the approved welding Procedure Specification (WPS) identified as ABF-WPS-D1.5-1001 Repair. Welding of what appeared to be one continuous excavation extending the entire circumference of the insert was in process and the QAI observed the work at this location appeared to be in general compliance with contract documents.
